PHASE I ENVIRONMENTAL SITE ASSESSMENT

**VANDERLINDE ELECTRIC
80-100 CHARLOTTE STREET
ROCHESTER, NEW YORK**

Date: May 23, 2002

Project No.: 2936E-02

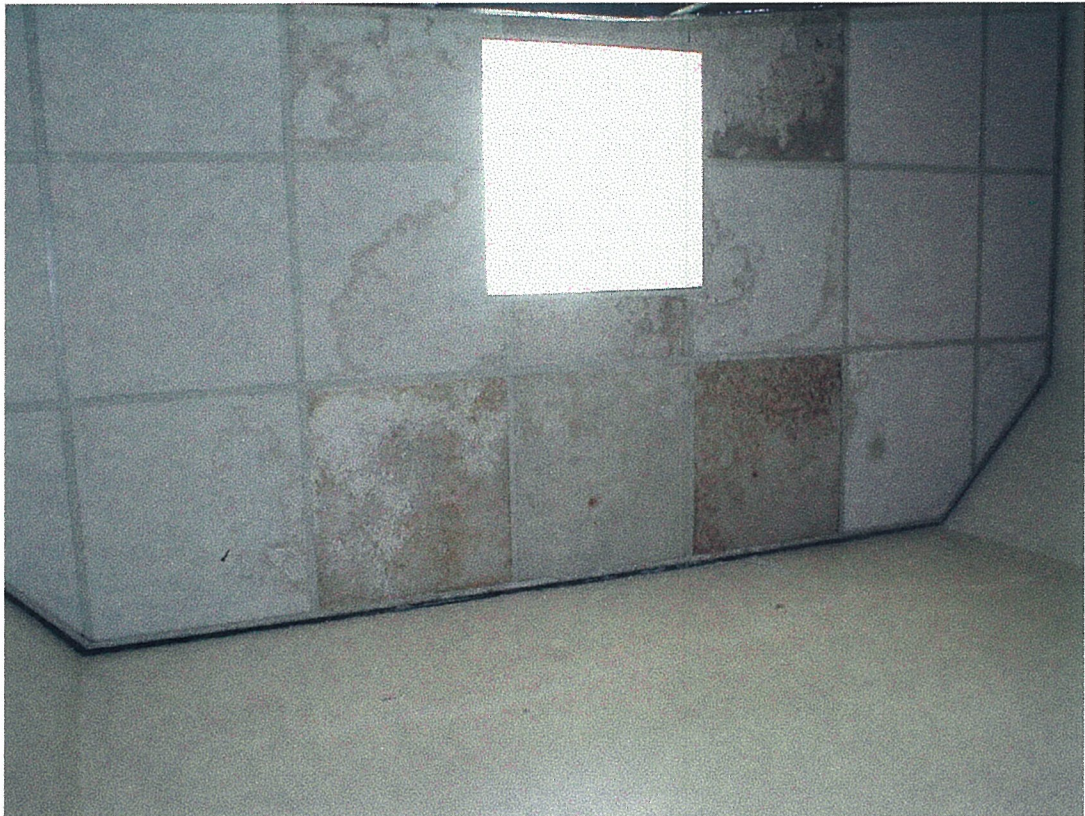
2. **Suspect Asbestos Containing Material (SACM):** At the time of the site visit, damaged acoustical ceiling tiles were observed in the stairwell located in the northeast portion of the assessed building. In addition, SACM in undamaged condition was observed at several other locations within the assessed building (refer to Section 5.1). If the assessed property is acquired by the City of Rochester, it was reported that this building will be demolished (refer to Section 7.1).

View of damaged ceiling tiles and skylight in northeast stairwell

Recommendations: Since it was reported that the assessed building is going to be demolished, it is recommended that a pre-demolition asbestos survey be performed. If the analysis indicates the presence of ACM within the assessed building, the ACM should be removed in accordance with applicable regulations prior to building demolition.

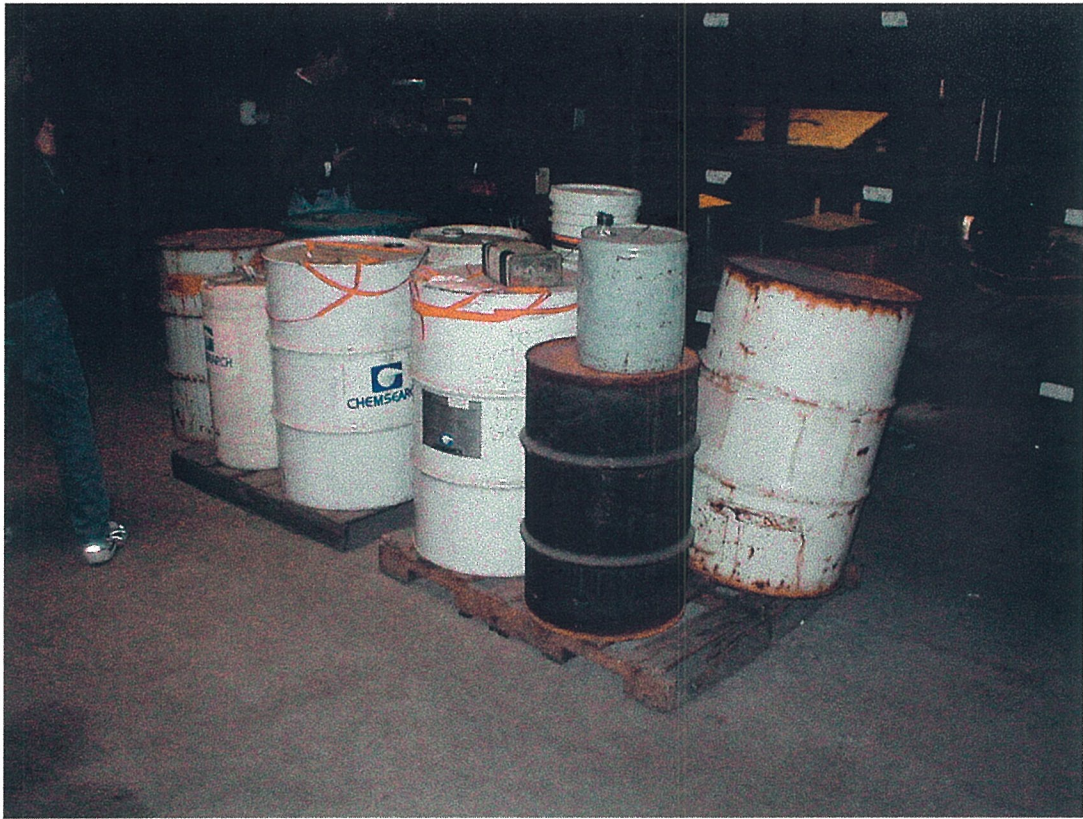
2. **Drums and Containers:** At the time of the site visit, numerous 55-gallon drums, 5-gallon buckets, and other containers were observed stored in the warehouse, motor repair shop, and truck bay area. Labels on some of the containers (i.e., waste solvent, etc.) suggest that some of these materials could be considered hazardous waste (refer to Section 3.6.2).

View of drums and containers staged in warehouse area

Recommendations: It is recommended that these drums and containers be removed from the assessed property and disposed of in accordance with applicable regulations.

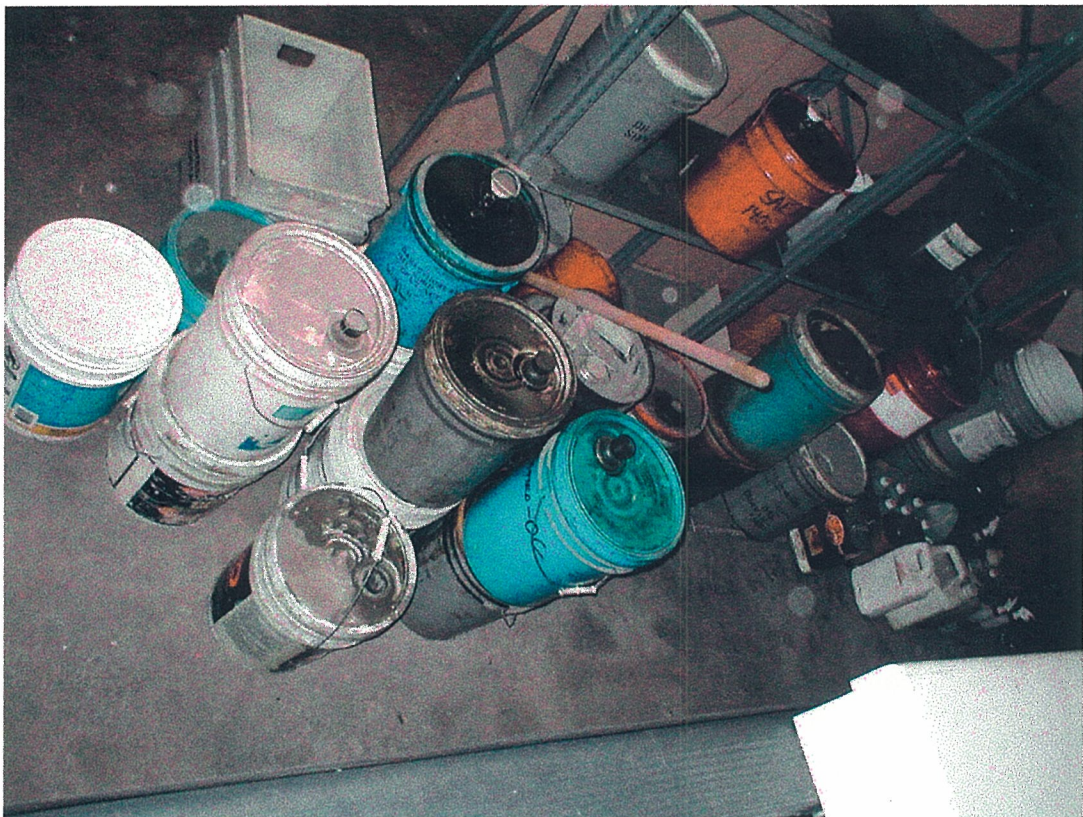
- Four 5-gallon and two 2-gallon gasoline containers; three 55-gallon drums (one labeled "used oil"); approximately twenty-five 5-gallon buckets of reported used gear oil, hydraulic oil, and cutting oil from the motor repair shop; and approximately ten 1-quart to 1-gallon containers of varnish located on the concrete floor and on shelves. The owner of the assessed property indicated that these containers were product and waste from when Vanderlinde operated the motor repair shop and would eventually be disposed off-site (refer to Section 4.1).

View of used cutting oil in truck bay area

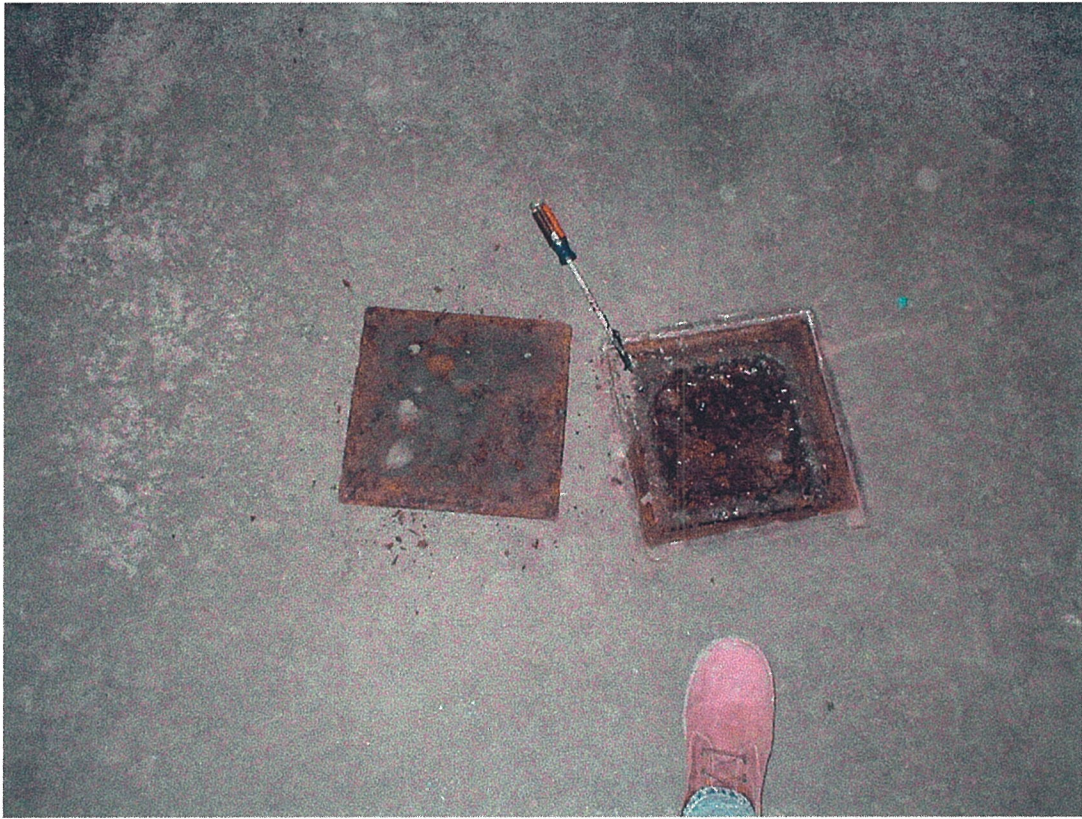
One floor drain was observed in the motor repair shop, and two floor drains were observed in the truck bay area of the assessed building at the time of the site visit (refer to Sections 3.4.2 and 6.2). The floor drain in the motor repair shop was in poor condition, and one of the floor drains in the truck bay area contained liquid with an apparent petroleum-like sheen.

- (3.4.2) Two floor drains were observed in the truck bay portion of the warehouse, one floor drain was observed in the motor repair shop, and one floor drain was observed in the bathroom adjacent to the motor repair shop. The owner of the assessed property indicated that these drains discharge to the public sanitary sewer system (refer to Section 4.1). A petroleum type substance was observed on the concrete floor beneath a pick-up truck parked over the drain in the truck bay area. This substance drained toward one of the drains in the truck bay. The cover was removed from the second drain in the truck bay and an apparent petroleum type sheen (i.e., rainbow sheen) was observed. The portion of the drain that could be observed was full of liquid and sediment, and the internal grate was rusted. The drain in the motor repair shop was in poor condition (broken concrete around the drain, rusted internal grate, etc.), and it also contained liquid and sediment.

View of floor drain in truck bay area

Recommendations: It is recommended that subsurface studies be performed on the assessed property in order to evaluate whether the above recognized environmental conditions have resulted in an environmental impact on the assessed property.

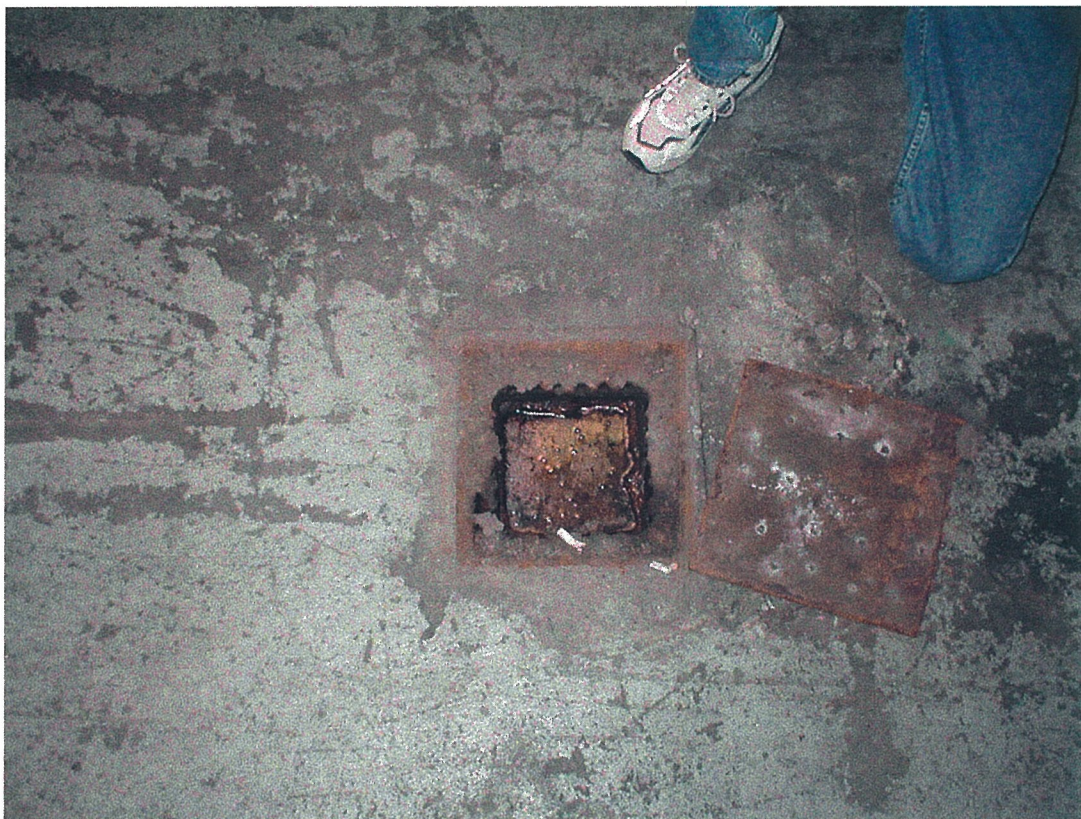
View of floor drain in motor shop area

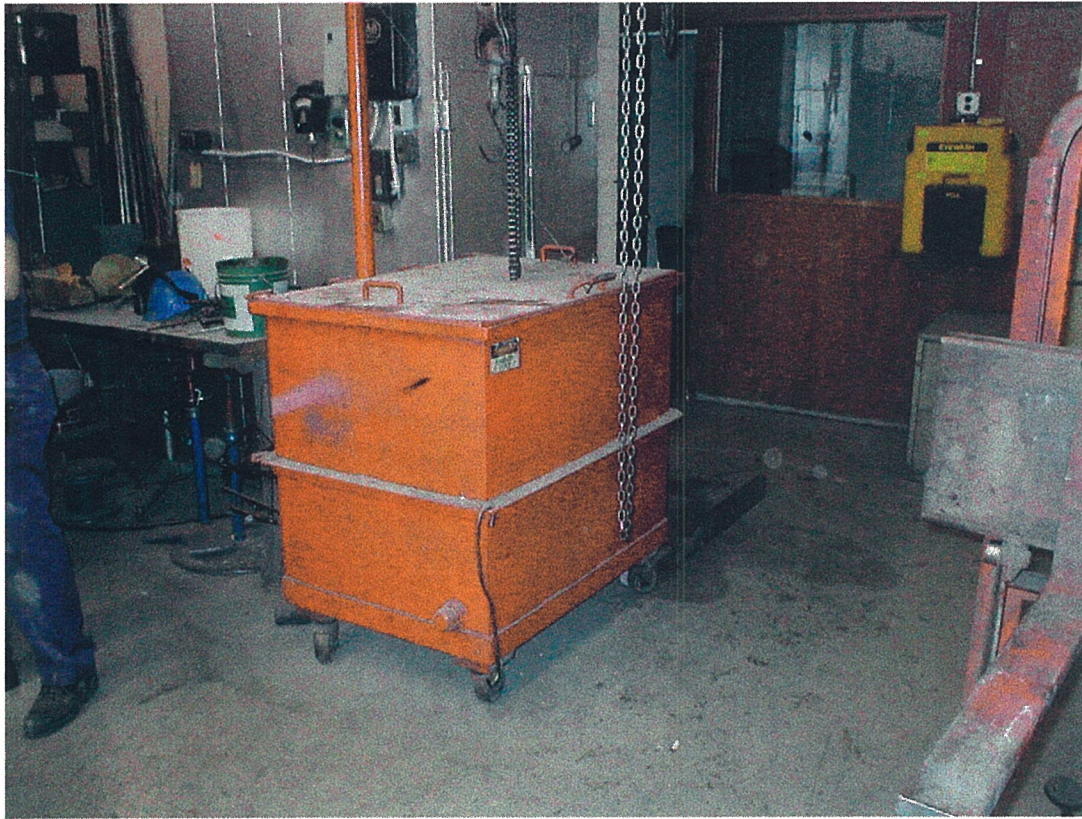
- Motors are placed in a "burn-out" oven to soften the coil wire in the old motor to facilitate its removal;
- The motor is then placed in a parts cleaner/solvent tank to remove debris;
- The new coil is placed in a varnish tank and then placed in the "bake oven" for hardening;
- The motor is then re-insulated and the new coil installed;
- New bearings are installed and the motor is reassembled.

(3.6.8) Machinery including lathes, drill presses, a "burn-out" oven, and a "bake oven", were observed in the motor repair shop area.

View of varnish dipping tank with bake oven in background

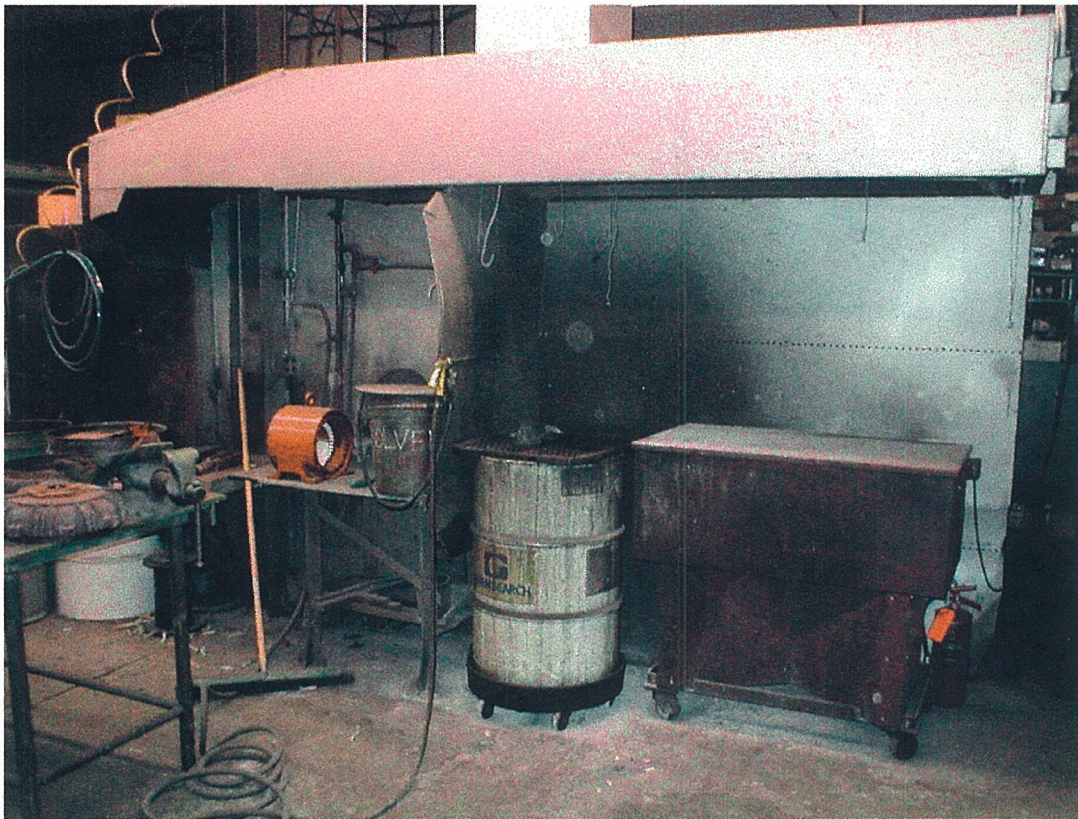
Staining was observed on the concrete floor near the solvent-based parts washer in the motor repair area and on the warehouse floor (refer to Section 3.3). Solvents and/or hazardous materials have historically been used and/or stored in these areas. Also, transformers and other electrical equipment may have been stored in the assessed building in the past (refer to Sections 3.4.1 and 4.2).

- (3.3) Black staining was observed on several areas of the concrete floor within the warehouse portion of the assessed building. Silver colored staining was also observed on the floor around the parts washer in the motor repair shop. The concrete floor in these areas appeared to be in good condition (i.e., not cracked, chipped, etc.).

View of parts cleaning area (note discoloration on floor)

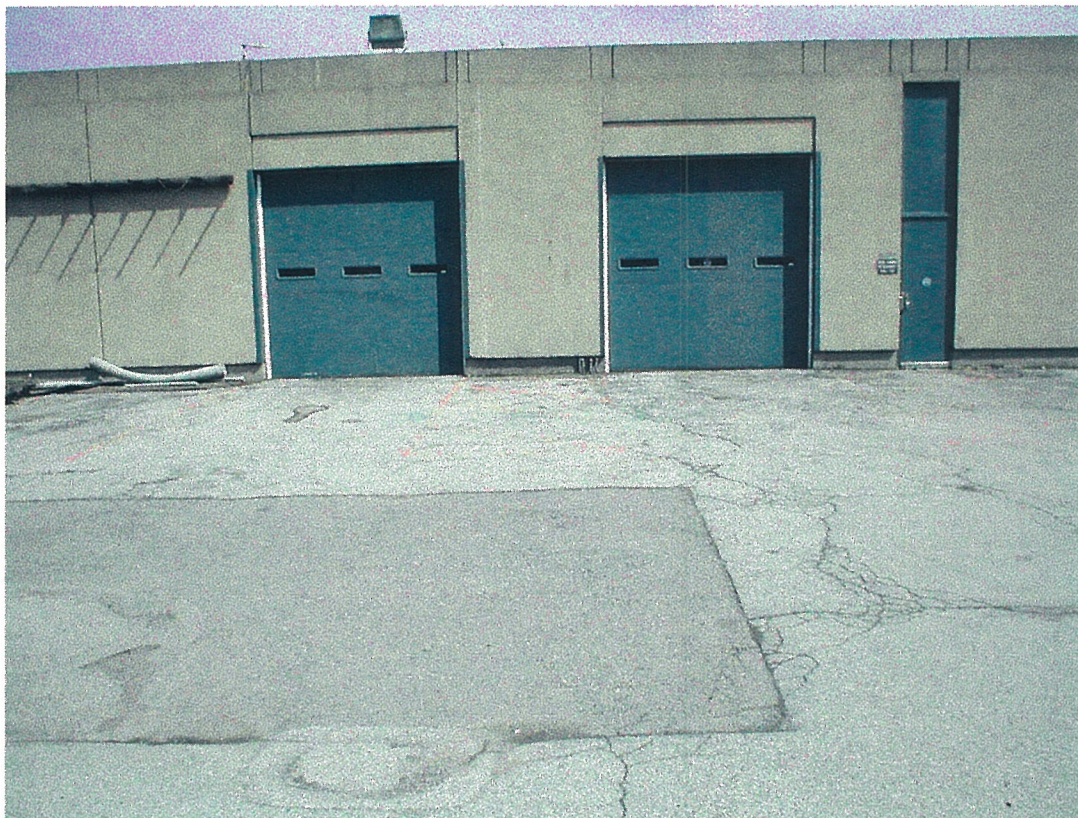
- (3.6.1) Evidence of storage tanks was not observed on the assessed property at the time of the site visit. However, the owner of the assessed property indicated that a gasoline UST was removed from the assessed property in 1988 (refer to Sections 2.2, 2.3.14, 4.1, 4.2, 6.1, and 6.2). The owner indicated that an asphalt patch observed in the parking lot west of the assessed building was the former location of the UST.

View to east of warehouse portion of assessed building with asphalt patch (reported former UST location) in foreground

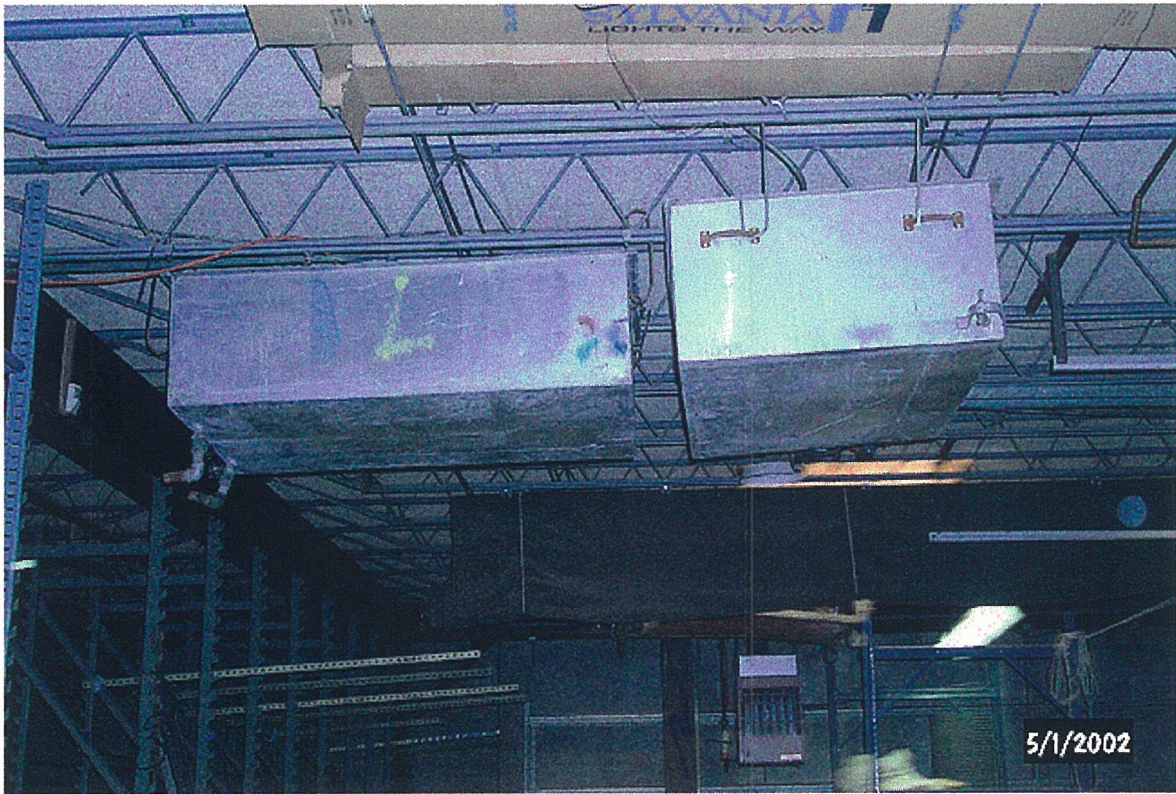
Storage of light ballast cleaning dip tanks.

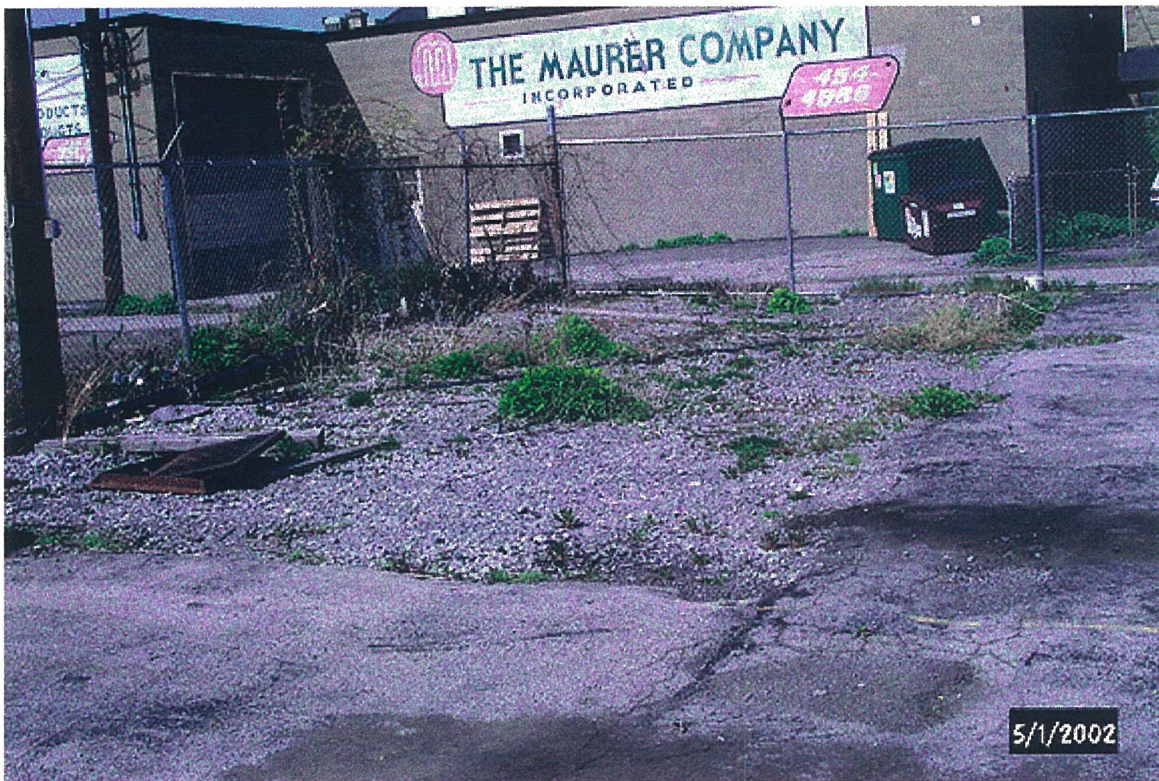
View of apparent surficial staining on paved and unpaved/gravel areas on the northwest corner of assessed property.

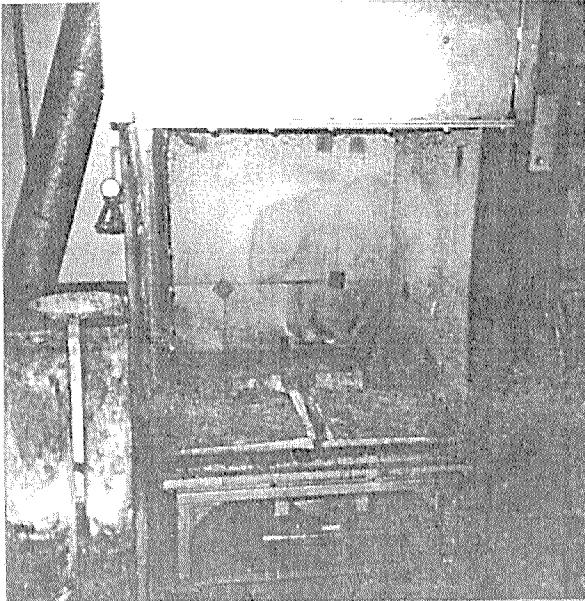
BURN-OUT OVEN

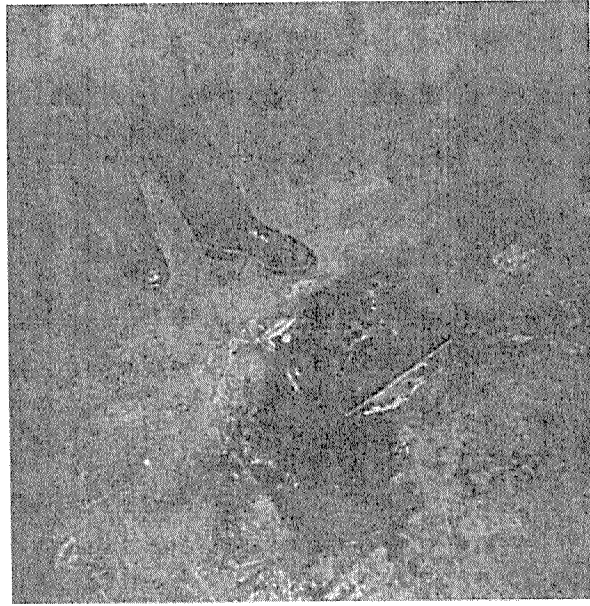
FLOOR DRAIN

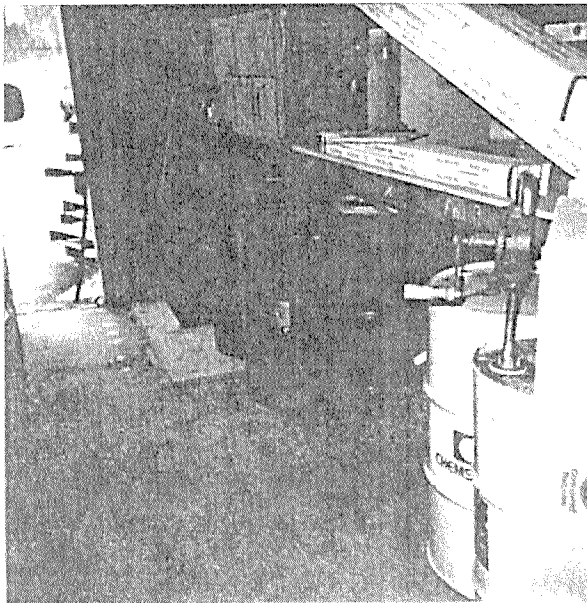
CUTTING OIL, SOLVENT STORAGE
